Department of Water Resources

BULLETIN No. 116-3

EARTHQUAKE DAMAGE TO HYDRAULIC STRUCTURES IN CALIFORNIA

JUNE 1967

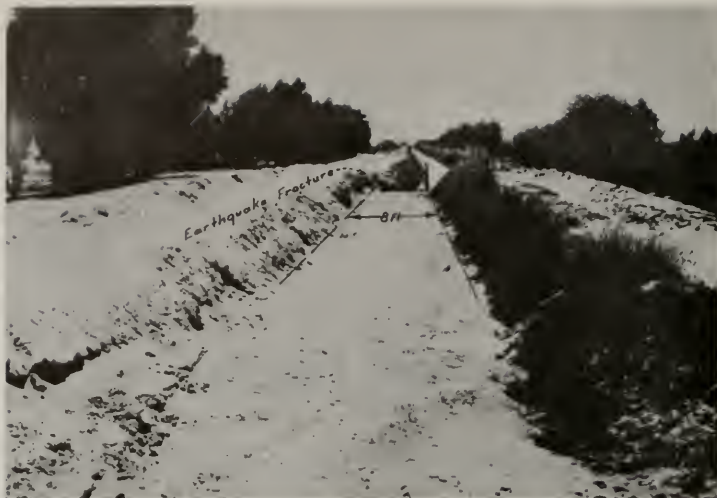
Canal Offset by Imperial Fault
Imperial Valley Earthquake, May 18, 1940

Typical fault displacement of a small canal in
Southern Imperial County
(U. S. Bureau of Reclamation photograph)

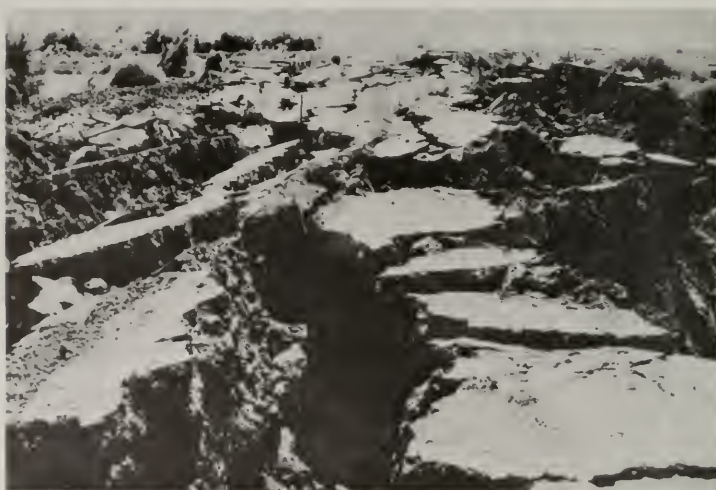
Levee Failure Caused by Foundation Shaking
Imperial Valley Earthquake, May 18, 1940

Damage to the banks of the All-American Canal in Imperial County due to foundation shaking. Photograph shows condition of heavy adobe banks between Drop No. 5 and Ash flume. (U. S. Bureau of Reclamation photograph)

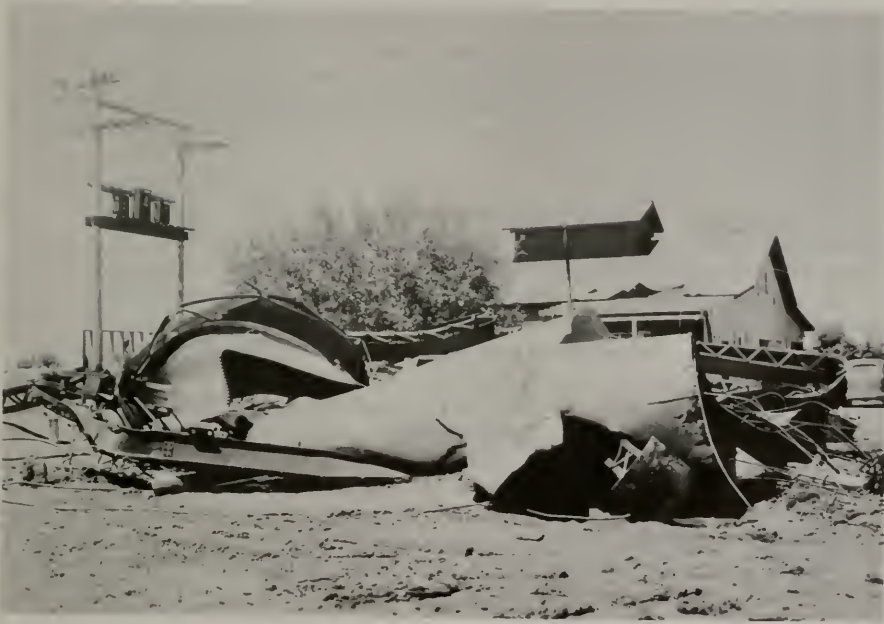
The 100,000-gallon water tank for the town of Imperial, California, collapsed.

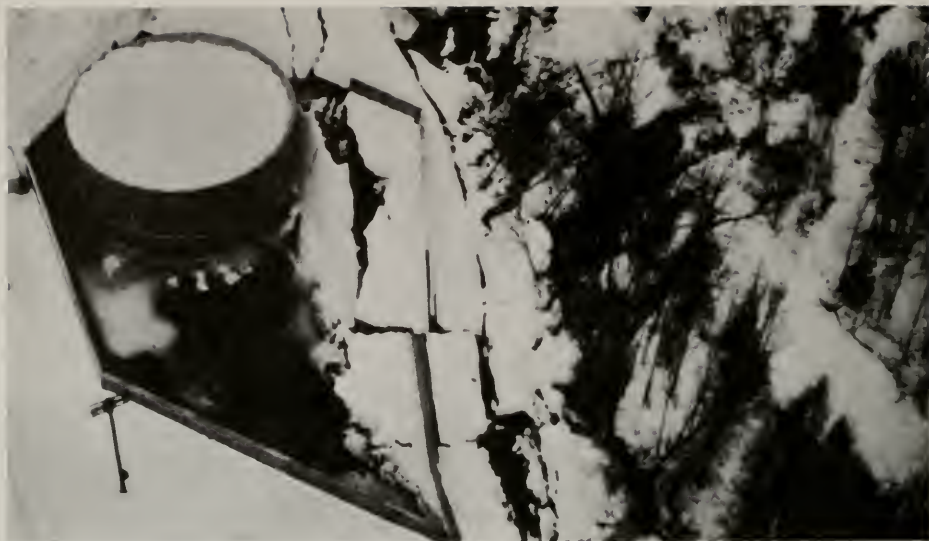
A close-up of the compressional buckle, the ruptured fuel tank, and the revetment at the foot of the landslide near the Alaska Native Hospital, Anchorage.

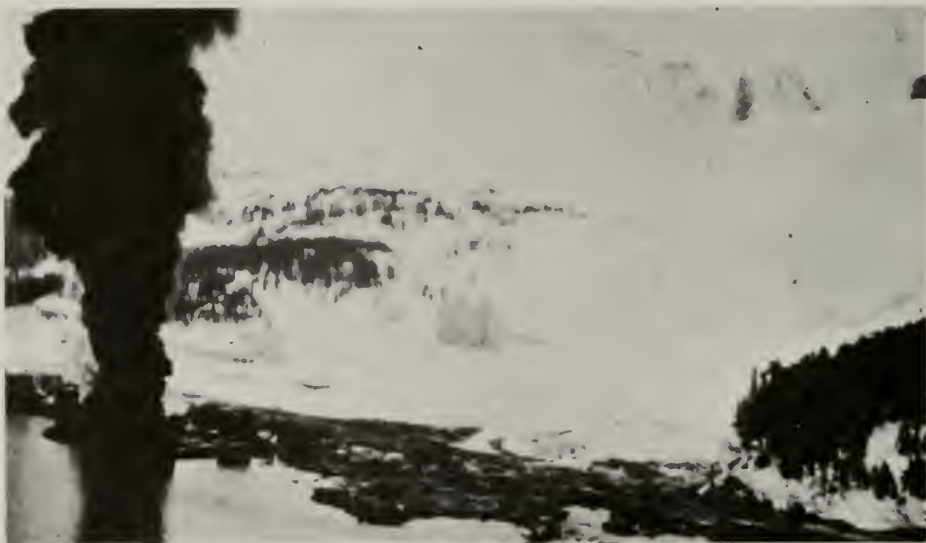
The dock area, a tank farm, and railroad facilities at Whittier were severely damaged by the surge-waves developed by underwater landslides in Passage Canal. The waves inundated the area of darkened ground, where the snow was soiled or removed by the waves.
